Baker Hughes Pipeline Management Group Casing Identification and Reporting

Presented July 2008

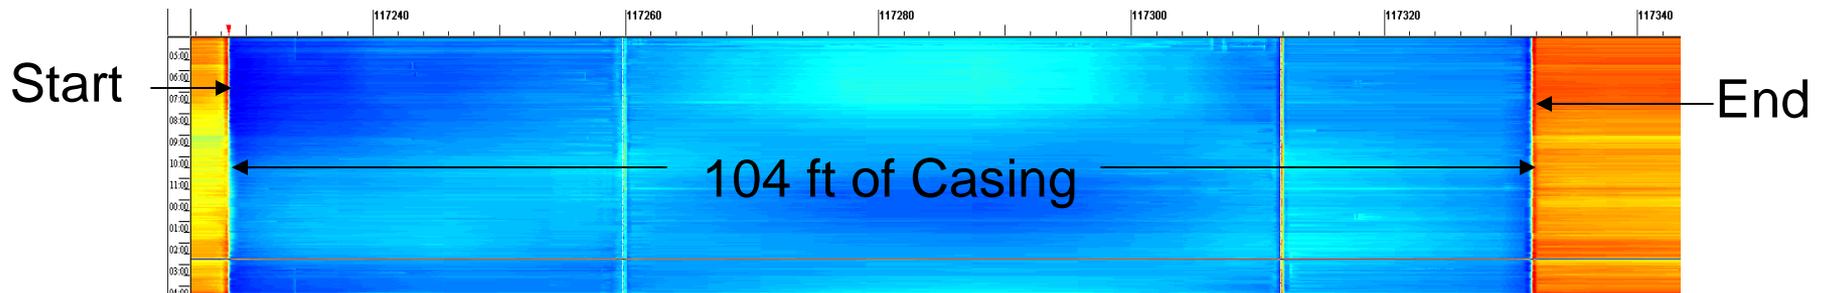
Detection of Casing

Casings are detected as a metal gain object around the full circumference of the pipe

The start and end of casing are evident in the data and estimated lengths of casings are provided

Probability of detection of a casing is 100%

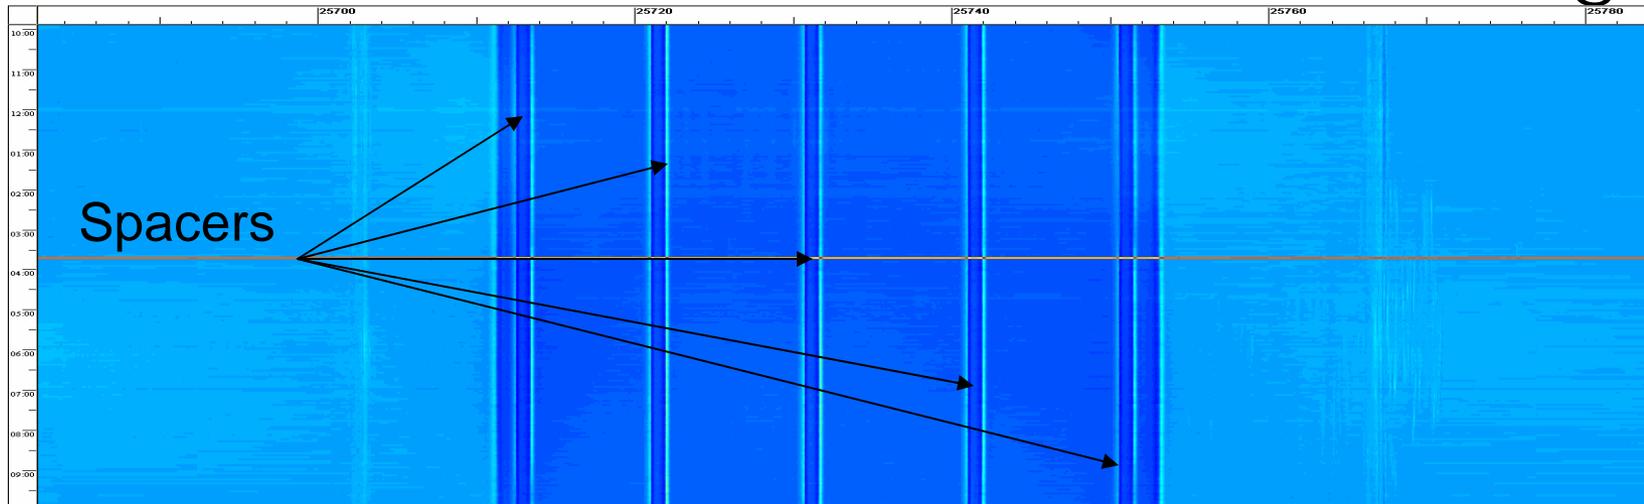
Detection of Features within a Casing

Spacers are found sandwiched between the carrier and casing pipe to isolate the casing pipe from the carrier pipe.

Most detectable spacers are found in older cased pipe pre-dating 1970, newer pipes either do not have cased crossings or the spacers are built entirely of nylon without carbon steel present.

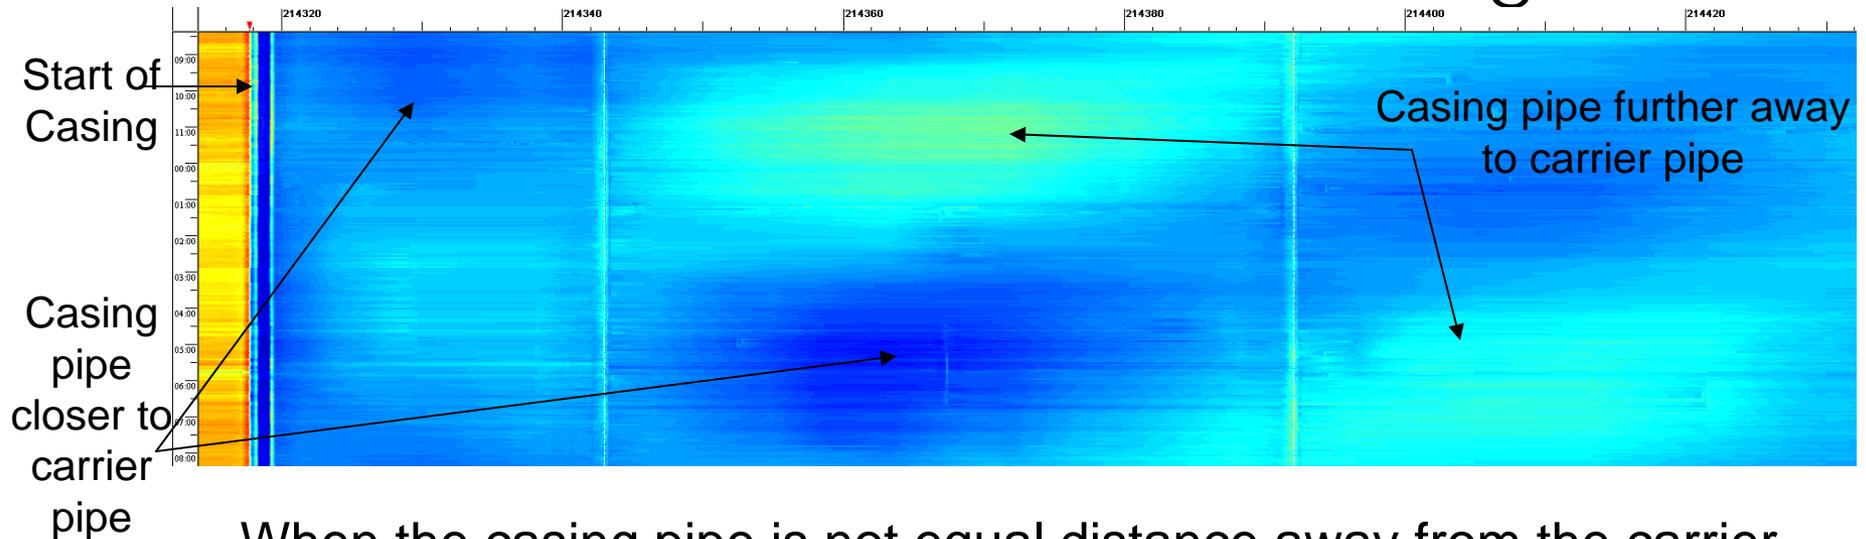
Detection of Eccentric Casings

When the casing pipe is not equal distance away from the carrier pipe it is thought to be eccentric. Detection of casing pipe's proximity to carrier pipe is well illustrated.

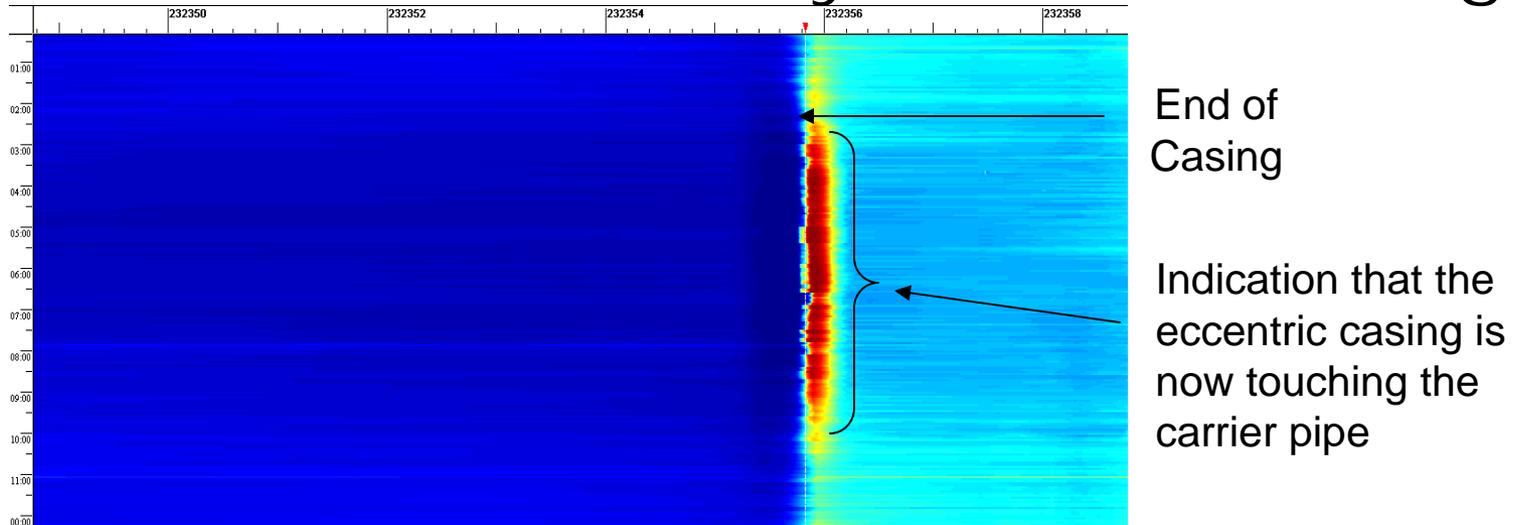
Detection of Mechanically Shorted Casings

When the casing pipe has come in contact with the carrier pipe a mechanical shorted condition exists. The cathodic protection is no longer effective in this cased crossing location. Probable location for future accelerated growth of metal loss.

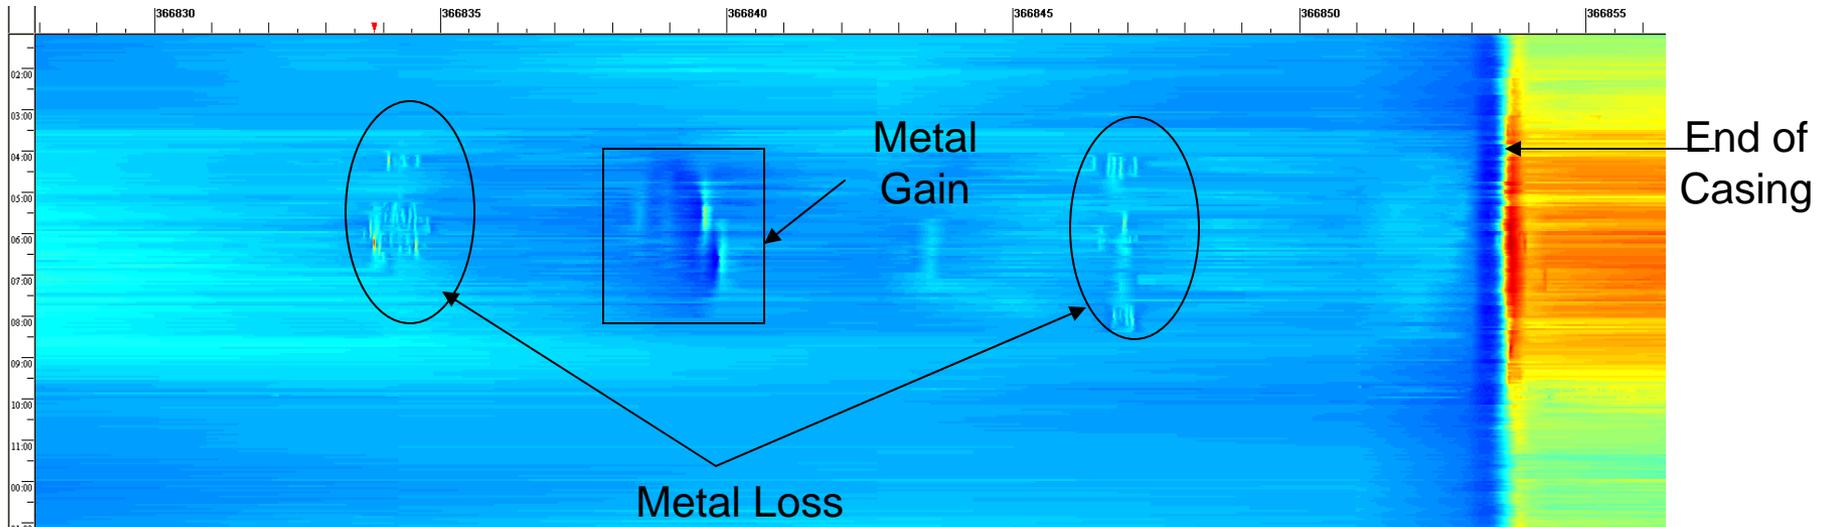
Detection of Metal Loss

Metal Loss (carrier pipe) under casing is detected very accurately by an MFL tool and sized within the specifications of the tool. Discriminating between internal and external metal loss on the carrier pipe is accomplished by different sensors on board the tool that are not adversely affected by the presence of the casing.

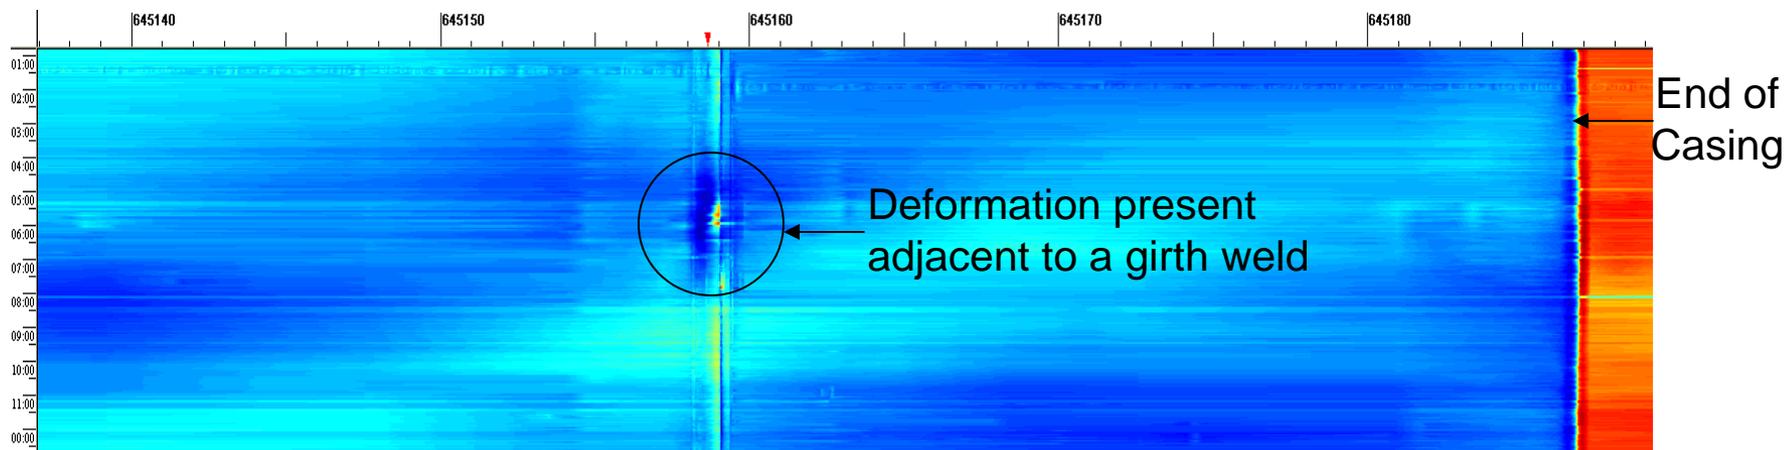
Detection of Deformation

Detection of deformations (dents) under casings is possible with MFL technology, but MFL alone cannot determine the % restriction of the deformation without the aid of caliper sensors.

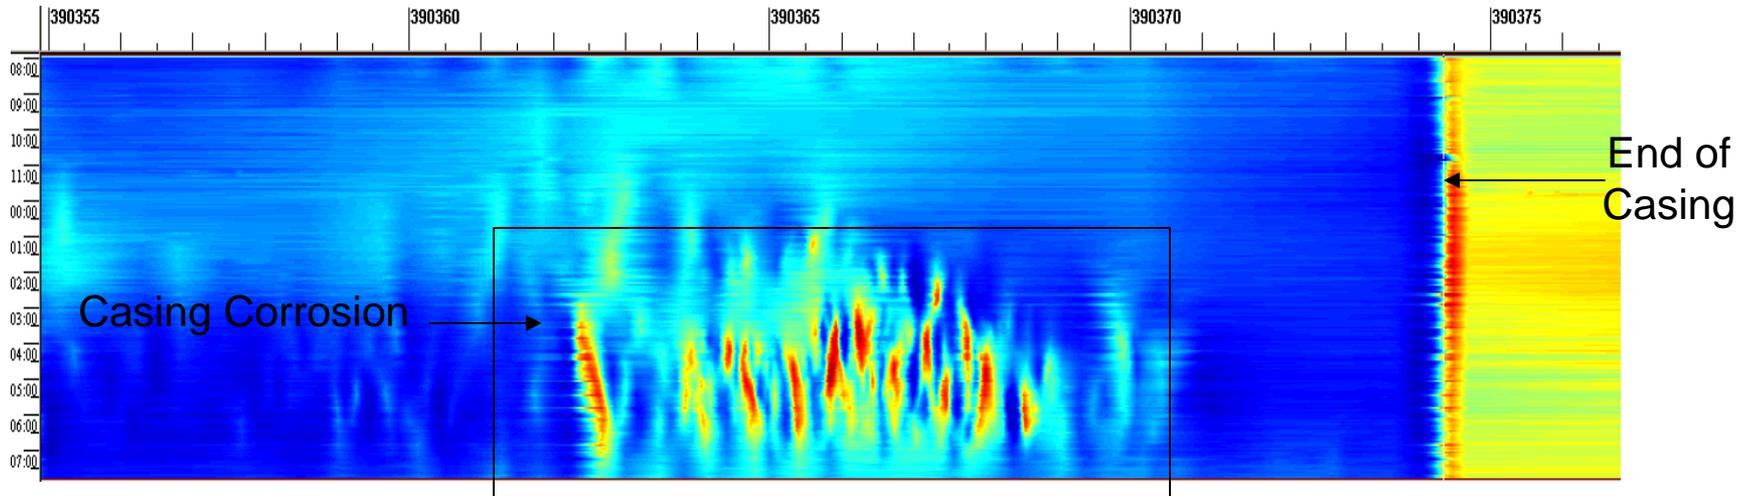
Casing Pipe Corrosion

Detection of metal loss on the casing pipe is possible, but there has to be significant amount of metal loss depth and length. Sizing accuracy is not provided for such conditions.
